HOUSE of REPRESENTATIVES

Appropriations Requests for Legislatively Directed Spending Items

4. Name of the entity that the spending item is intended for:
Grand Rapids Art Museum
5. Physical address of the entity that the spending item is intended for:
101, Monrow Center St NW, Grand Rapids, MI 49503

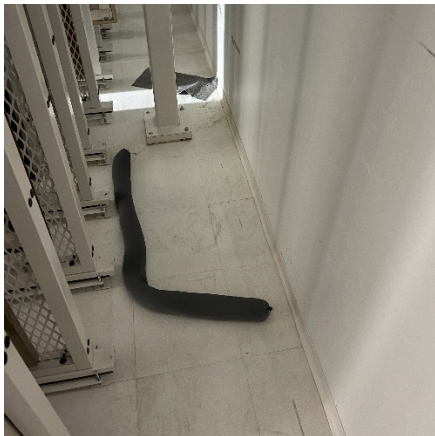
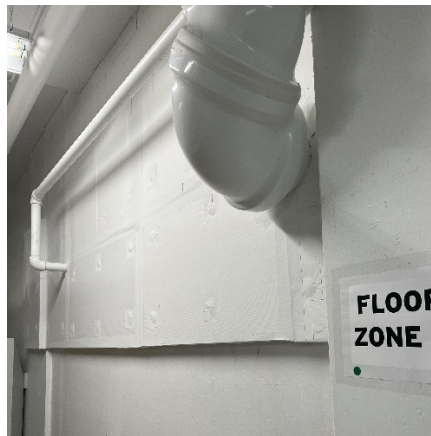
North wall of Art/Bulk Storage shows signs of water infiltration. Sliding vertical art racks north wall is leaking from above requiring a need for water absorption material on the floor.

The walls are common to the outside open court area. Investigate the base of exterior wall flashing condition.

Recommendations: Determine cause and source of water infiltration. Resolve condition.

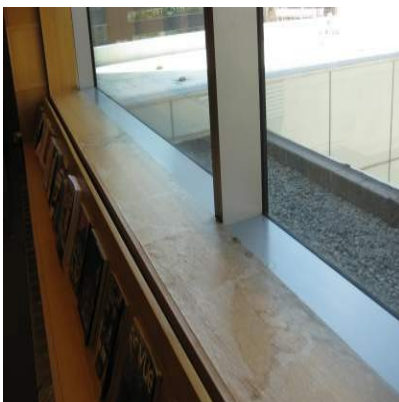
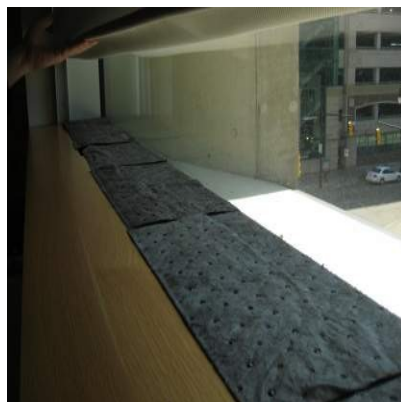
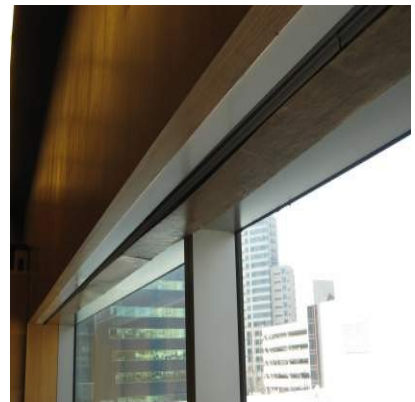
Observation: Exterior windows are set to the exterior, surrounded by concrete wall construction, in what becomes a deep pocket. The head, jamb and sill are clad with finished wood. The humidity levels in the building and the depth of the pocket resulting in a lack of air movement across the windows has caused a buildup of water on the aluminum framing. Some water is dripping from the head of the aluminum framing between the framing and the wood trim. (Per owner, the maintenance protocol is to wipe the windowsills every three hours.)

Recommendations: Heat/air movement needs to be addressed. Aluminum framing does not appear to have a thermal break in the system. 1-inch (?) insulated glass can only achieve an R value of 2.5. (This combination of aluminum and glass is common to the building and moisture is controlled with heat and air movement elsewhere.)

Wall at sill of window should be rebuilt, adding at least electric fin tube the full length of the window. (Open toe kick drawing air in and a continuous slot grill at the wood windowsill allowing heated air to wash the window.)

Replacement of the window system may be the only solution to eliminate the condensation.

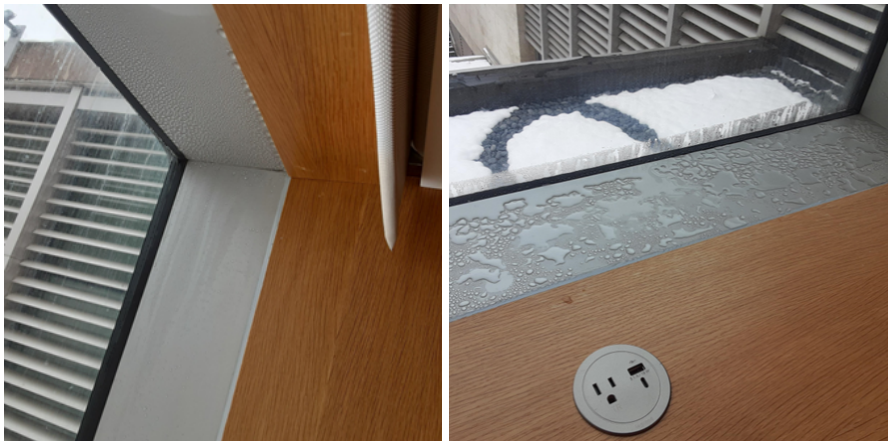
Two photos showing Winter 2024 conditions. Head on left. Sill on right.

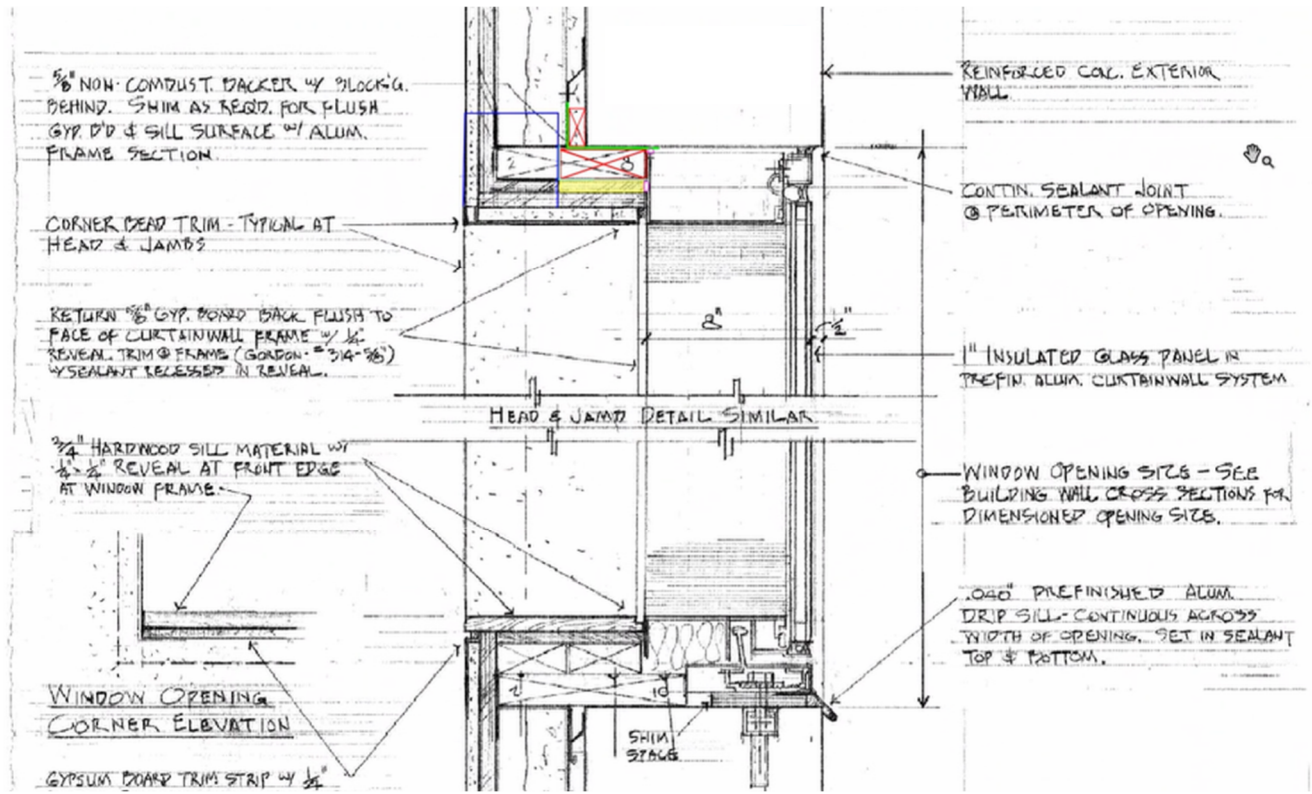
Original detail of exterior window at Library showing custom channel window system without thermal.

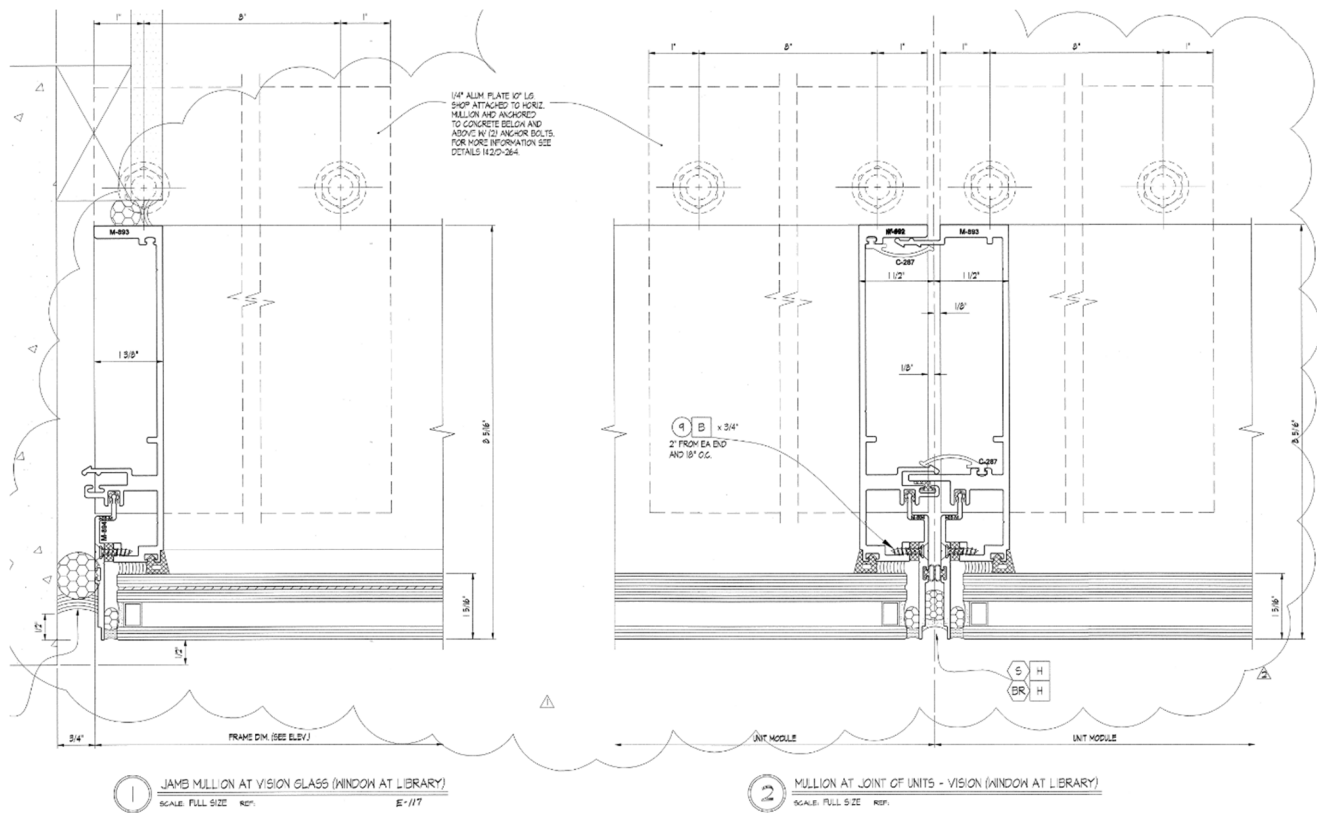
Curtainwall Shop Drawing
'Very cold' window section
without thermal breaks. A cold
path directly into building using
high humidity.

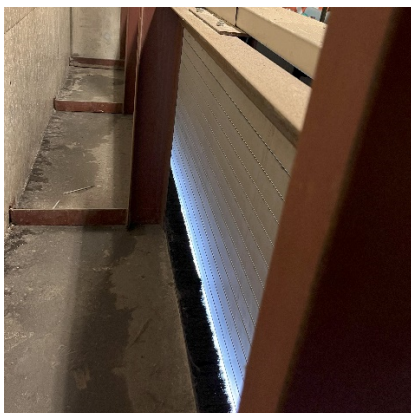
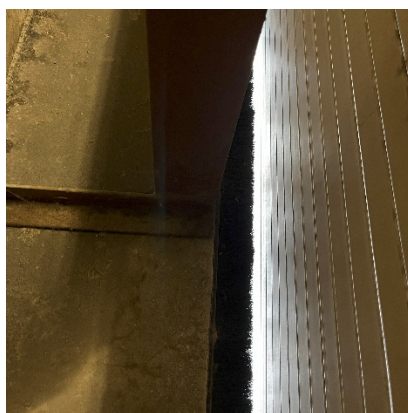
Name: Dock Door
 Priority: Critical (6 months - 1 year)
 Location: West facing wall
 Manuf Type: Unknown
 Today's Cost: \$1,100
 Observation: Overhead coiling door functioning but shows signs of bowing in due to wind loading.
 Reason for Replacement: N/A (No replacement planned)
 Evaluation Rating: 4 - Most functions perform
 Recommendations: Adjustments need to be made to the head condition. Weatherstrip brush seals need to prevent air from blowing directly into the building in 'Back Stage' area. Suggest adjusting mounting to follow the concave door profile or replace seal with depth required. (Depth not known.)

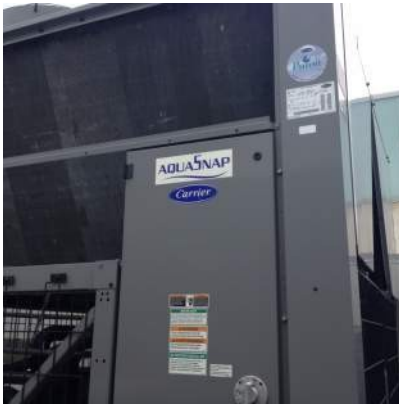
Evaluation Rating: 3 - Some functions do not perform

Recommendations: Replace air handling unit with more energy efficient equipment. Problems were reported with providing N+1 capacity efficiently.

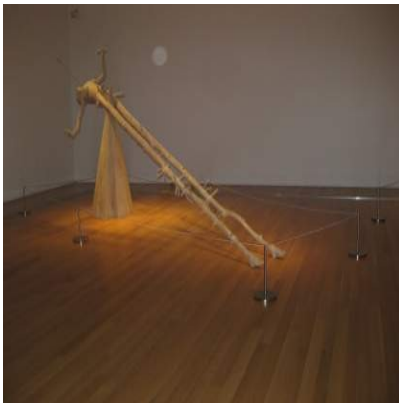
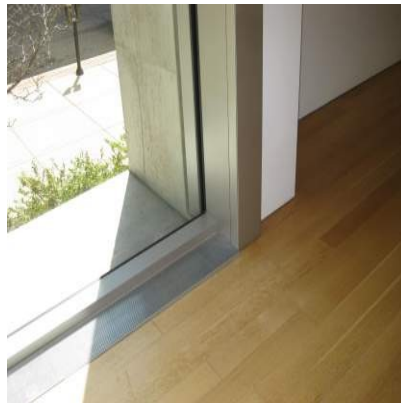
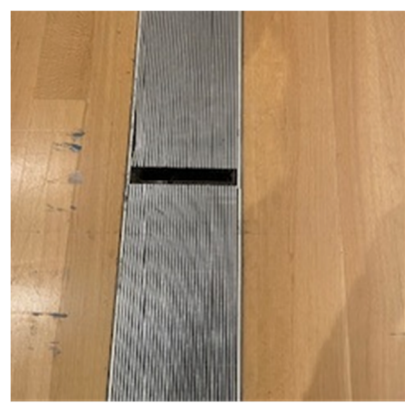
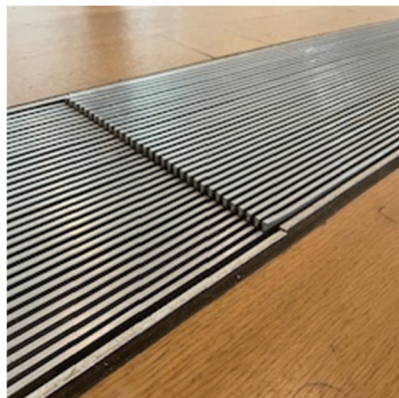
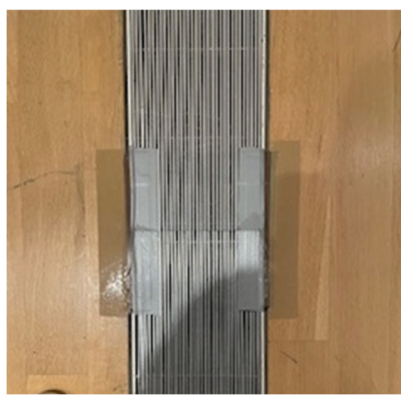
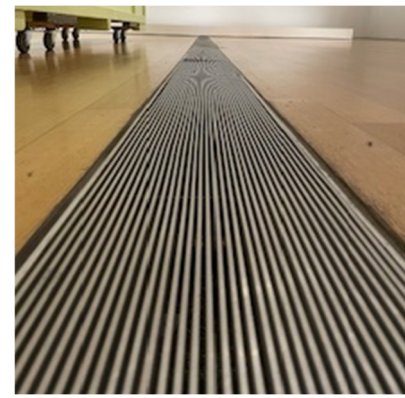
Evaluation Rating: 5 - All functions perform for wood floor AND 3 – Some functions do not perform for floor grates.

Recommendations: Keep up with the maintenance of the traffic coating to extend the life of the wood.
Replace all floor grates.

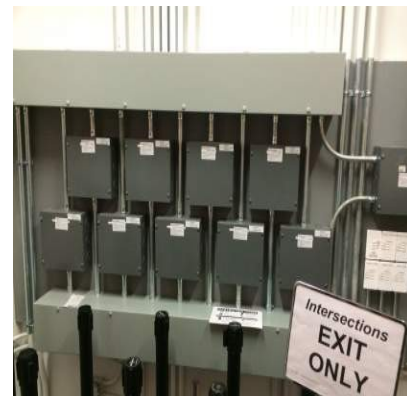
Evaluation Rating: 3 - Some functions do not perform

Recommendations: Due to the age, functional issues and obsolescence of the lighting control system it is recommended to replace with an up to date system. Recommend an Acuity nLight or equivalent system. A wireless control system should be considered to add flexibility in controlling fixtures where current zoning may not be desired in hard lid ceilings.

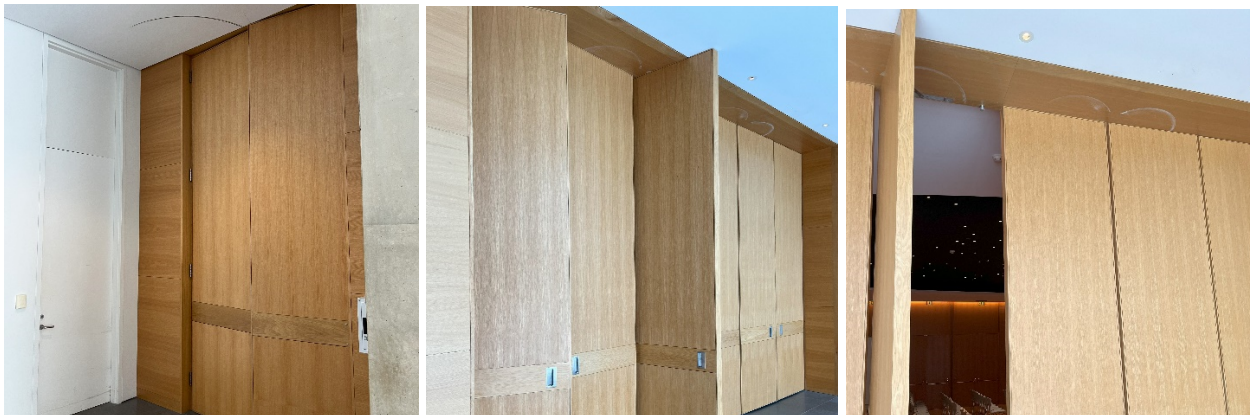
Evaluation Rating: 4 - Most functions perform

Recommendations: To be able to continue using the doors, modify doors to correct height and correct veneer issues.

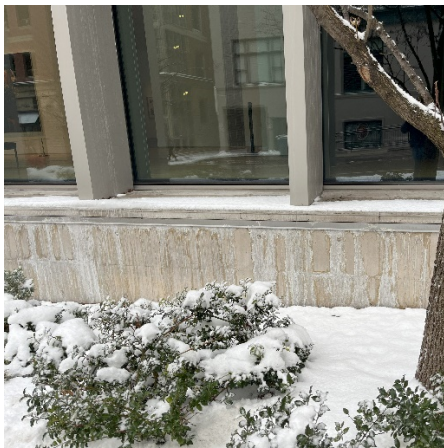
Evaluation Rating: 5 - All functions perform 'AND' 2 – Most functions do not perform

Recommendations: A study focused on each transparent opening in the facility should be undertaken as airflow and heat may be mitigating the condition at various areas of the building. Energy used and lost, and controlling very tight humidity and temperature requirements is a very big issue within this facility. Condensation is also deteriorating adjacent construction to the curtainwall.
