THE JACKSON COUNTY SHERIFF'S OFFICE & CORRECTIONAL FACILITIES

Current Problems and Conditions

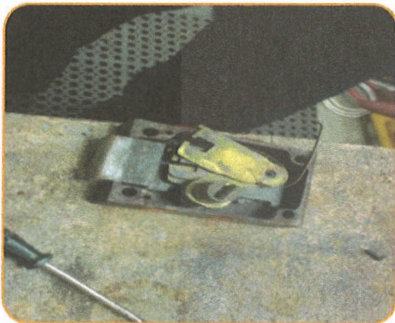
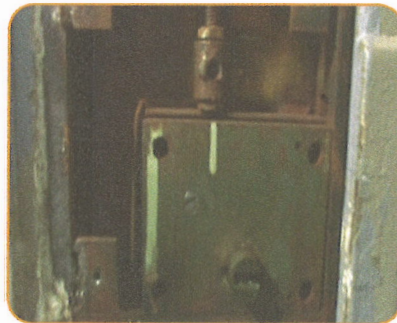
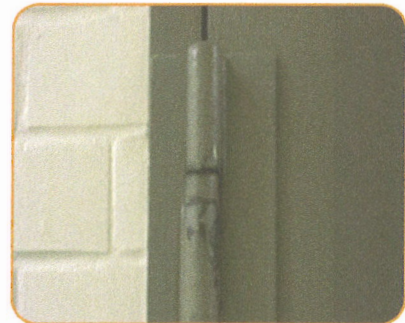
- A large security concern is the breaking of locks on cell doors. This is not an unusual event.
- Most door locks and hinges are original; meaning they are 70 years old.
- Parts are no longer made for them and must be fabricated. This takes longer time to accomplish increasing the security risks, and the cost is extreme.

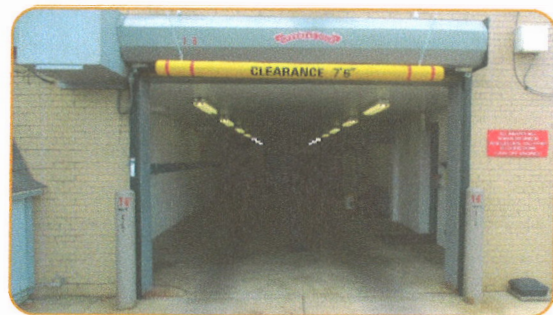
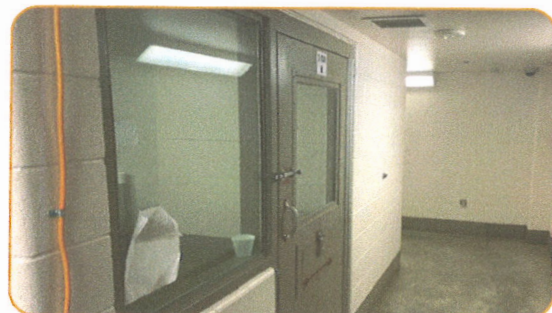
- Design constraints limit patrol cars to one-way access, causing delays of up to 30 minutes for officers to exit, compromising public safety.
- Isolation cell situated facing away from the guard station creating difficulty to manage.
- Inmate laundry is outside the secure area, requiring trustees to leave the jail, posing supervision and security challenges.
- The majority of cells within the facility are visible and audible to each other, posing risks to facility security and Deputy safety.
