HOUSE of REPRESENTATIVES

Appropriations Requests for Legislatively Directed Spending Items

4. Name of the entity that the spending item is intended for:
Grand Rapids Art Museum
5. Physical address of the entity that the spending item is intended for:
101, Monrow Center St NW, Grand Rapids, MI 49503

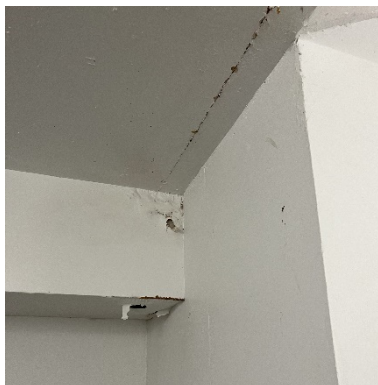
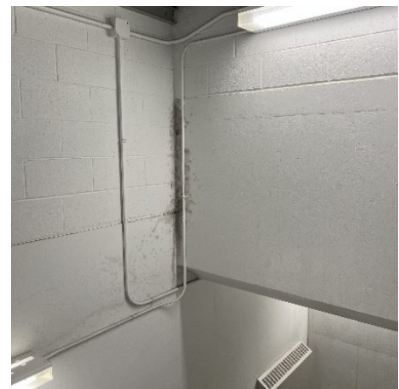
Recommendations: Various repairs due to roof leaks that have been addressed with a new roof.

- Mitigate mold in corner of wall shown in photo.
- Repair and prime, with rust inhibitor, the ceiling crack shown in photo.
- Remove bulkhead construction. Reconstruct after addressing hidden deficiencies.
- Clean and reseal floor at stair landing from stair to Security entry door.
- Descale handrail, grind and repaint with rust inhibitor.

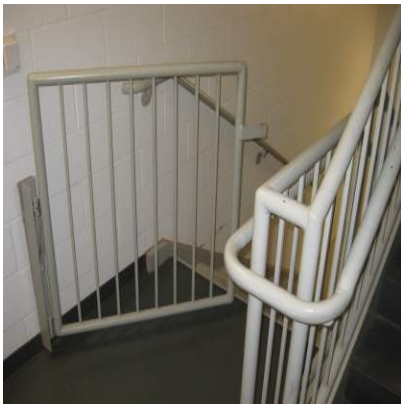
Reason for Replacement: Code / Regulatory

Evaluation Rating: 4 - Most functions perform

Recommendations: Reconstruct the gate 'stop' to prevent exit to basement

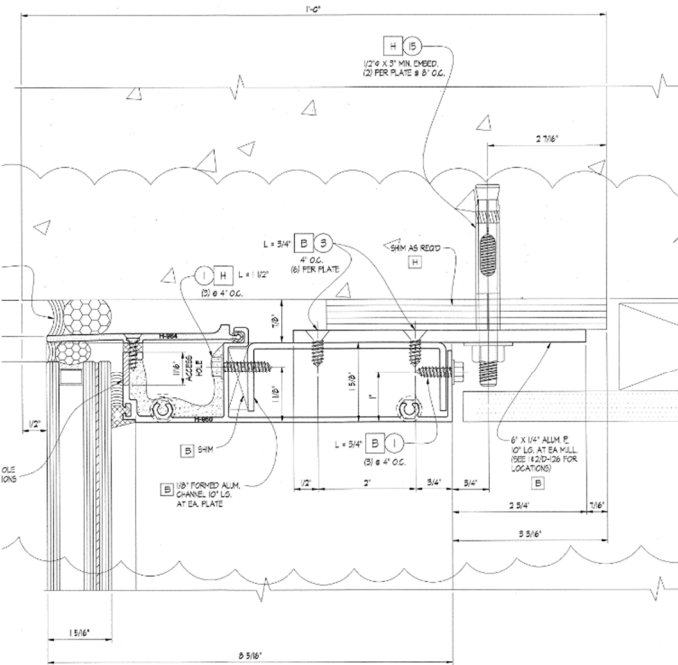
1 TOP HORIZONTAL AT VISION (WINDOW @ LIBRARY)
SCALE: FULL SIZE REF: C2 / A634 E-117

Curtainwall Shop Drawing
'very cold' window section
without thermal breaks.

Replacement of the window system may be the only solution to eliminate the condensation.

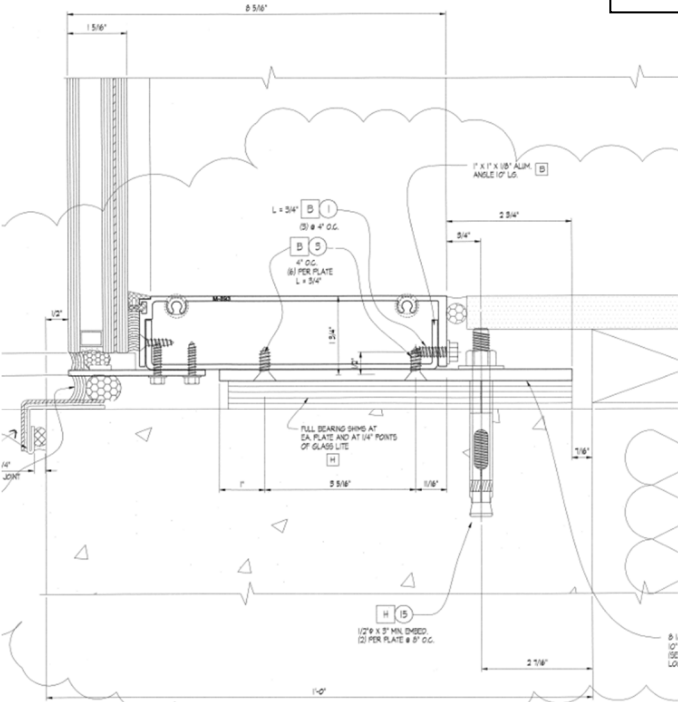
1 SILL AT VISION (WINDOW @ LIBRARY)
SCALE: FULL SIZE REF: C2 / A634 E-117

Curtainwall Shop Drawing
'Very cold' window section
without thermal breaks. A cold
path directly into building using
high humidity.

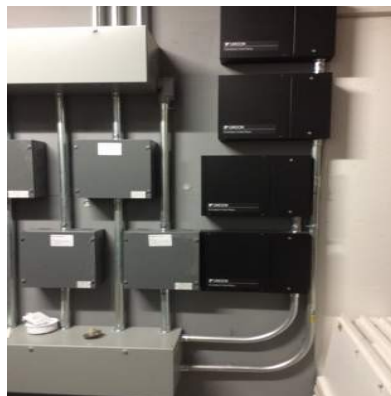
Reason for Replacement: The lighting control system is obsolete and obtaining replacement and obtaining replacement hardware is becoming more difficult as time goes on.

Evaluation Rating: 3 - Some functions do not perform

Recommendations: Due to the age, functional issues and obsolescence of the lighting control system it is recommended to replace with an up to date system. Recommend an Acuity nLight or equivalent system. A wireless control system should be considered to add flexibility in controlling fixtures where current zoning may not be desired in hard lid ceilings.

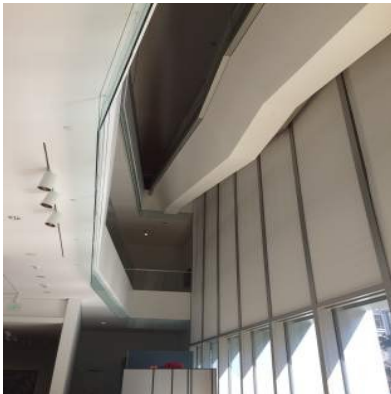
Reason for Replacement: Code / Regulatory
Age / Useful Life
Energy Efficiency
Life Safety / Health

Evaluation Rating: 1 - Non-Functioning

Recommendations: The lighting should be upgraded to LED to reduce maintenance frequency or replaced with fixtures that are located in areas that are easier to maintain. This area needs to be illuminated to be able to provide adequate lighting for egress out of the building.

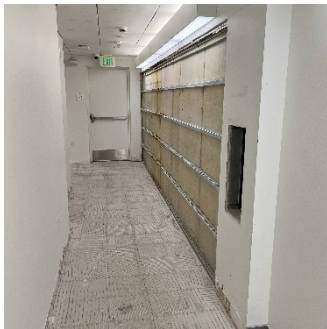
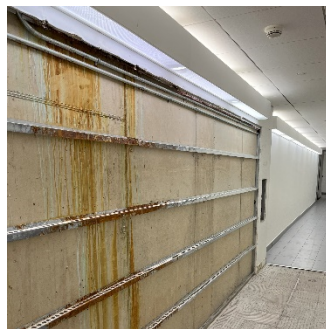
Evaluation Rating: 1 – Non-functioning

Recommendations: Before any work being done on the interior, exterior deficiencies need to be corrected. (reflecting pool). After confirming that there are no more leaks, do all interior modifications.

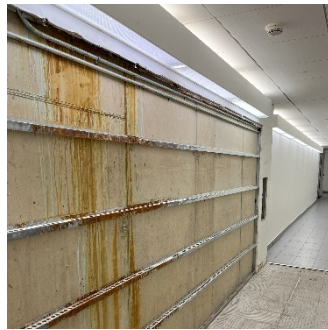
Evaluation Rating: 1 – Non-functioning

Recommendations: Before any work being done on the interior, exterior deficiencies need to be corrected. (reflecting pool). After confirming that there are no more leaks, do all interior modifications.

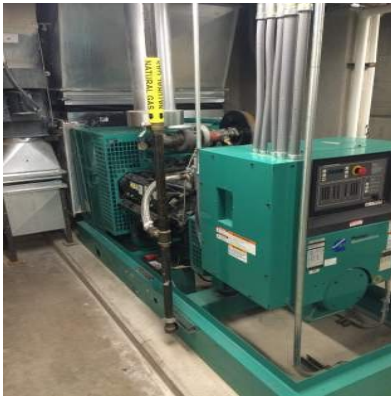
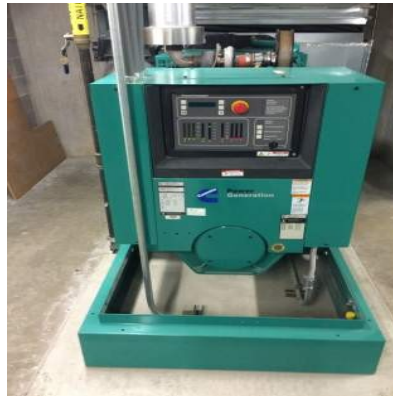
Observation: Current generator appears to be in great condition and has been run each month as required to meet the codes. There has been no significant change in the loads from the original construction of the building.

Evaluation Rating: 5 - All functions perform

Recommendations: Continue to do monthly testing and yearly maintenance to improve the longevity of the unit.

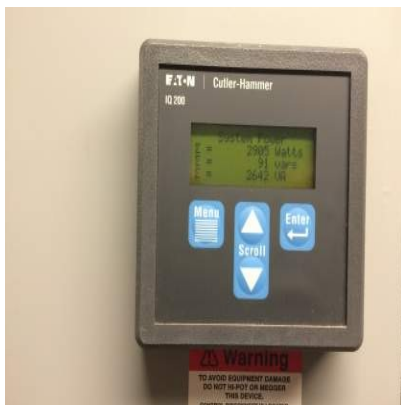
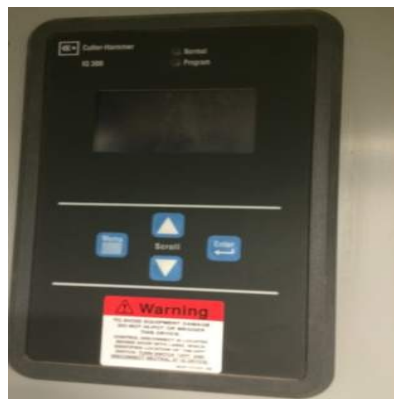
Name: Metering Equipment

Evaluation Rating: 5 - All functions perform

Recommendations: None at this time.

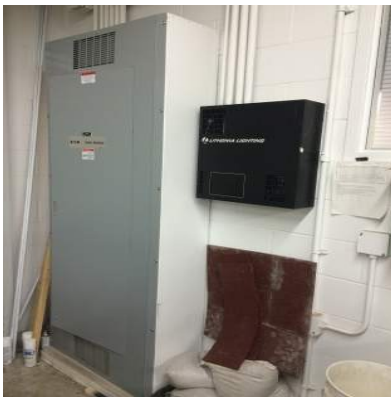
Reason for Replacement: The lighting control system is obsolete and obtaining replacement hardware becoming more difficult as time goes on.

Evaluation Rating: 3 - Some functions do not perform

Recommendations: Due to the age, functional issues and obsolescence of the lighting control system, it is recommended to replace in kin with an up to date system.

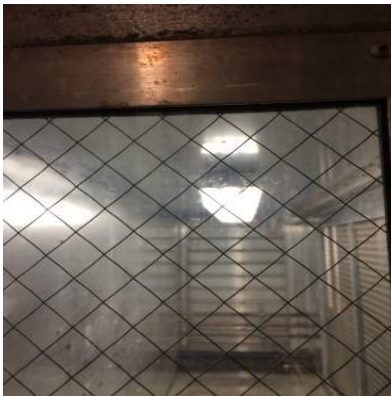
Name: Mechanical Light fixtures

Reason for Replacement: Energy Efficiency

Evaluation Rating: 5 - All functions perform

Recommendations: It is recommended to replace these fixtures with LED equivalent when they fail with LED fixtures utilizing less wattage and reducing maintenance requirements.

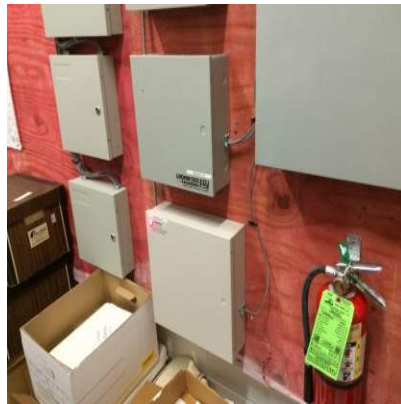
UniFormat Section: D70 - Electronic Safety and Security
Name: Door Hardware Systems
Priority: N/A
Location: Various locations throughout the facility
Manuf Type: Lenel, Locknetics
Today's Cost: N/A
Observation: Current system appears to be functioning and operating efficiently.
Reason for Replacement: N/A (No replacement planned)
Evaluation Rating: 5 - All functions perform
Recommendations:

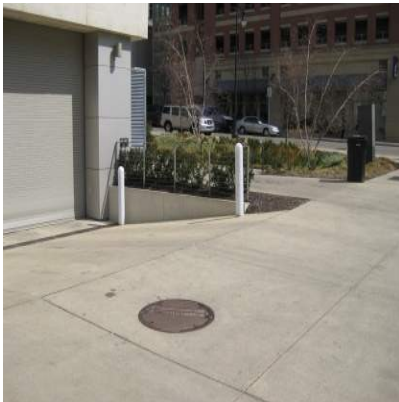
UniFormat Section: B1010.50 - Ramps

Evaluation Rating: 3 - Some functions do not perform

Recommendations: Modify area to function as required by facility operations.

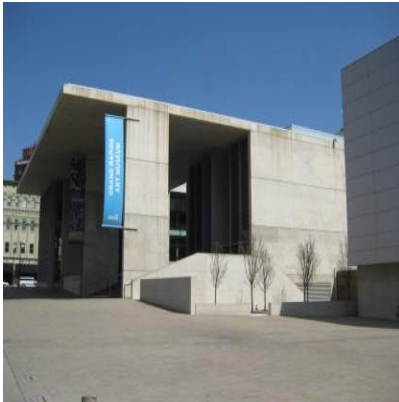
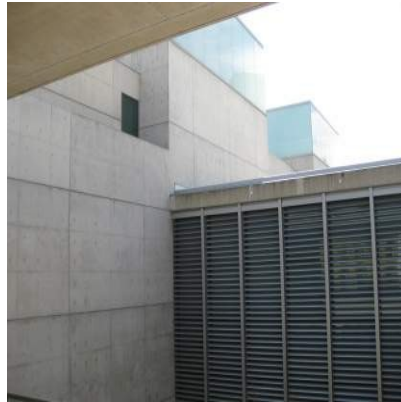
Name: Exterior Concrete

Evaluation Rating: 5 - All functions perform

Recommendations: None

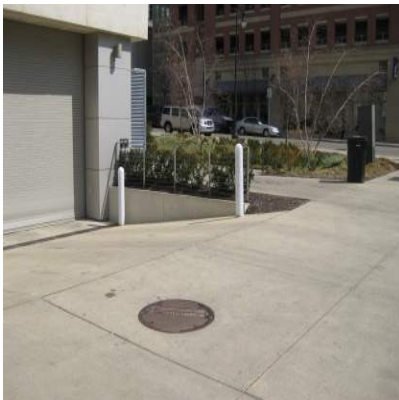
Observation: See Parking /Engineering/Bulk Storage for observations and recommendations.

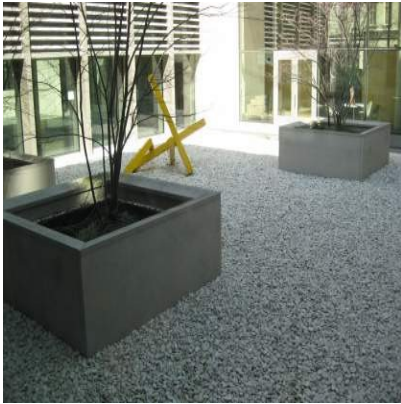
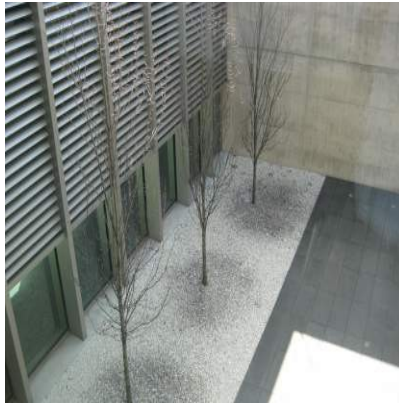
Observation: Not observed but during conversation it was determined that there was a leak in one planter that needed to be addressed.

Evaluation Rating: 3 - Some functions do not perform

Recommendations: Repair
